Army Lodging Wellness Recommendation

Fort Bliss - Final Submittal

August 14, 2003

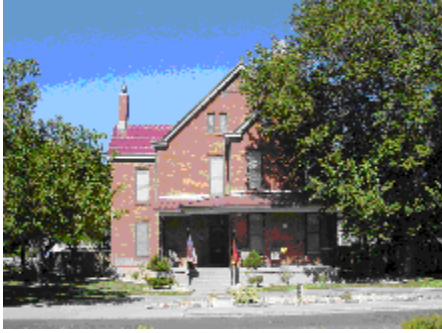
Building 00220

Building 220, constructed in 1893, houses 1 DVQ suite. This facility is in fair condition but does not meet Lodging standards and cannot be reconfigured without significant reconstruction. The cost to make improvements and to bring this facility up to Army Lodging standards will exceed the 50% replacement cost.

Building 220 was constructed in 1893. The 4,026 square foot facility contains a single DVQ with a full kitchen. The building is functioning as a family suite for high ranking visitors.

Our recommendation is to remove building 220 from the Lodging inventory, allowing the installation to determine an alternate use for this facility. This facility will be removed from the Fort Bliss Wellness Solution and Lodging Master Plan.

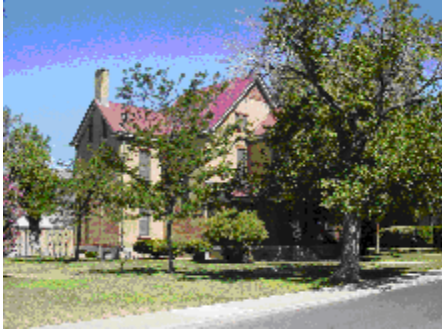
Building 00223

Building 223, constructed in 1893, houses 1 DVQ suite. This facility is in fair condition but does not meet Lodging standards and cannot be reconfigured without significant reconstruction. The cost to make improvements and to bring this facility up to Army Lodging standards will exceed the 50% replacement cost.

Building 223 was constructed in 1893. The 3,837 square foot facility contains a single DVQ with a full kitchen. The building is functioning as a family suite for high ranking visitors.

Our recommendation is to remove building 223 from the Lodging inventory, allowing the installation to determine an alternate use for this facility. This facility will be removed from the Fort Bliss Wellness Solution and Lodging Master Plan.

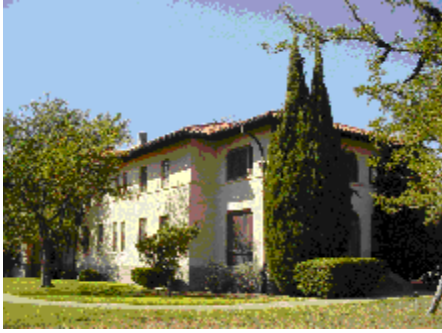
Building 00243

Building 243, constructed in 1939, is an historical structure housing 20 extended stay rooms. This facility is in fair condition but does not meet Lodging standards and cannot be reconfigured without significant reconstruction. The cost to make improvements and to bring this facility up to Army Lodging standards will exceed the 50% replacement cost.

Building 243 was constructed in 1939. The 25,600 square foot facility contains 20 lodging units, which are functioning as extended stay rooms.

Our recommendation is to remove building 243 from the Lodging inventory, allowing the installation to determine an alternate use for this facility. This facility will be removed from the Fort Bliss Wellness Solution and Lodging Master Plan.

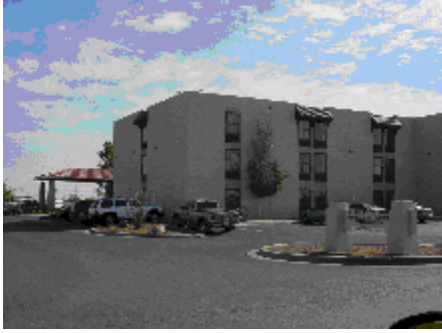
Building 01744

Building 1744, initially constructed in 1989, received a major addition in 1997. This building has 151 standard stay rooms and 3 family suites, and is the main Lodging facility on the post. The building is in good condition, but several support spaces are not included and are required by current Army Lodging standards. The cost to make improvements and to bring up to Army Lodging standards will not exceed the 50% replacement cost.

Building 1744 was originally constructed in 1989. It serves as the main lodging facility for the post and has all administrative and front of house activities and most back of house functions. A major facility expansion in 1997 increased the overall building area to 79,635 square feet. The facility contains 151 standard stay rooms and 3 family suites.

Our recommendation is to retain building 1744 in the Lodging inventory, and to renovate support spaces to meet current standards. This facility will continue to serve as the main Lodging facility in the Fort Bliss Wellness Solution and Lodging Master Plan.
